Cellar Conversion, to wine cellar Ticehurst Surrey

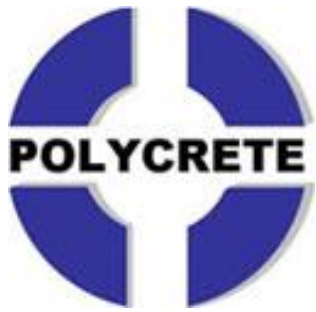
The top three pictures show the installation of the waterproofing system following the removal of the brick on earth floor which revealed a quagmire of saturated clay.

The waterproofing system consists of an underfloor drain channel (Waterguard) which can be seen in the top RH picture at the base of the cavity wall drain membrane as a grey strip. The top left picture shows the sump and pump system which was ultimately concealed within a corner cupboard. A membrane was applied to the floor with a new concrete floor slab laid over it.

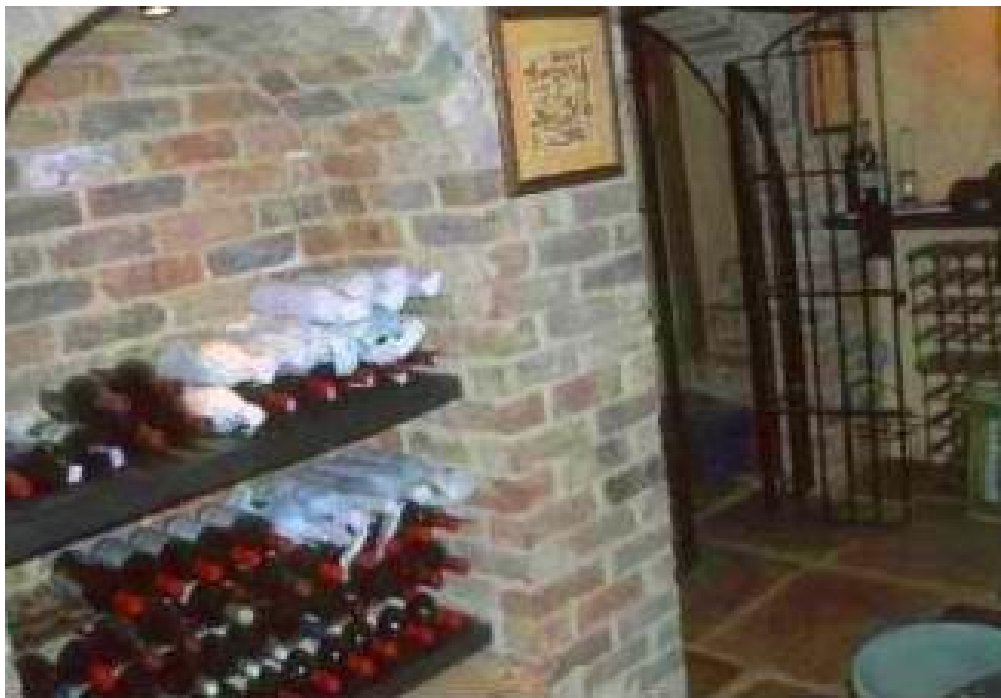
The main picture, to the left, show the beautiful and atmospheric finished wine cellar.

The walls were then lined with decorative brick and storage racks and the concrete floor was finished with earthenware tiles.
