## Crypted vault cellar conversion Farnham

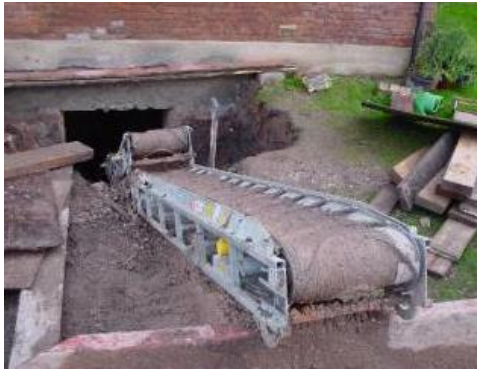
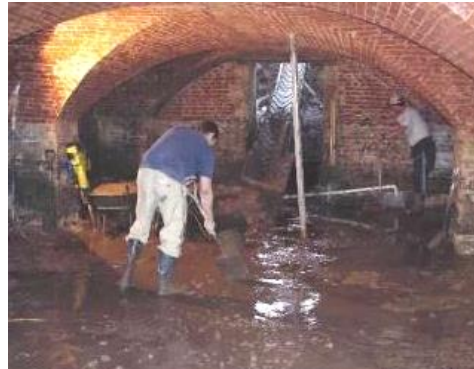
To provide more headroom we removed the brick floor and dug down by 400mm. During this excavation we revealed the original Victorian waterproofing method, which consisted of drainage channels created within the fabric of the brick floor.

This is one of several Victorian underfloor drainage systems that we have revealed and it is interesting to note that underfloor drainage was used BEFORE waterproof renders and coatings were developed. Modern underfloor channelling systems such as Waterguard and our own Basedrain channel are really a return to the tried and trusted philosophy of removing the water by drainage rather than trying to hold it back.

By installing the 'modern' drainage system we were in fact reinstating the same principles that the Victorians used.

Membranes were used on the vertical sections of wall, lined with plasterboard and the arched brick was lightly sandblasted and treated with a clear resin coating.

An opening was created in the apex and a spiral staircase installed; window wells were created at either end to facilitate natural light and emergency egress as can be seen in the main picture to the left.
