Cellar Conversion, Victorian end terrace south London

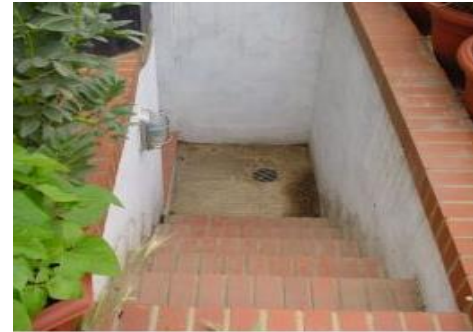
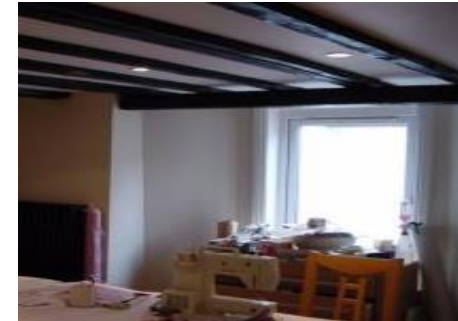
A new external stairwell can be seen externally and internally (top right two pics) thus allowing a secondary means of escape as well as introducing natural light.

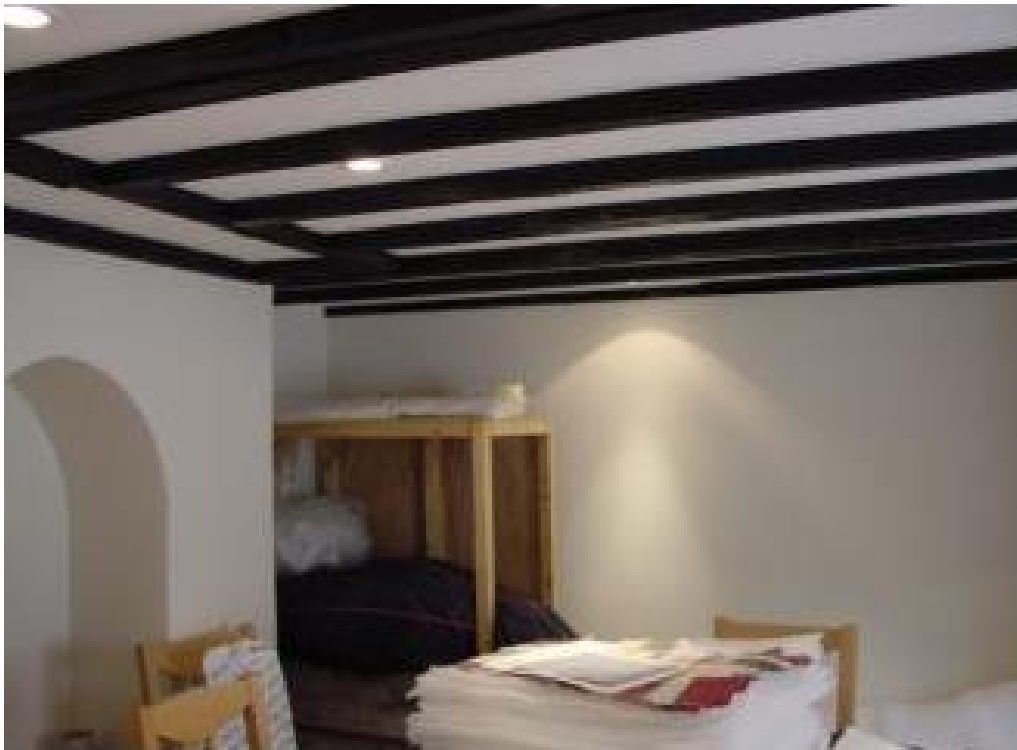
To preserve headroom, recessed plasterboard panels and lighting were fitted in-between the ceiling joists as can be seen in main picture to the left showing the finished room.

Other walls were lined with ourThermaDry insulated membrane and lined with plasterboard and an underfloor drainage system was installed to prevent the future risk of flooding.
