New Build Basement Farnham

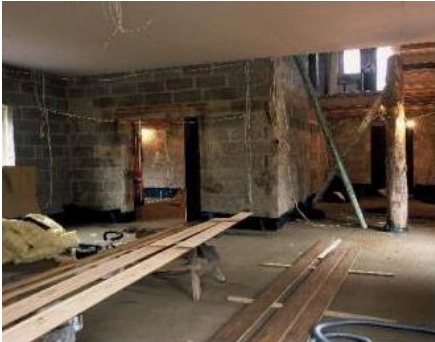
This was a newly built property (2003) with a 'semi-basement', only the front half being below ground by virtue of it being on a sloping site.

This led the architect to make a very common mistake assuming that ground drainage would not be necessary and that an external stick on sheet membrane would suffice for the waterproofing.

After heavy rain, the basement flooded, just before the house was finished and all internal linings, stud walls and joinery had to be stripped out (top left).

We solved the problem by installing:

- an internal sub-floor drainage channel (Waterguard),
- three perforated sump liners each with mains pump and battery back-up and
- drained cavity membranes to the walls and floor.

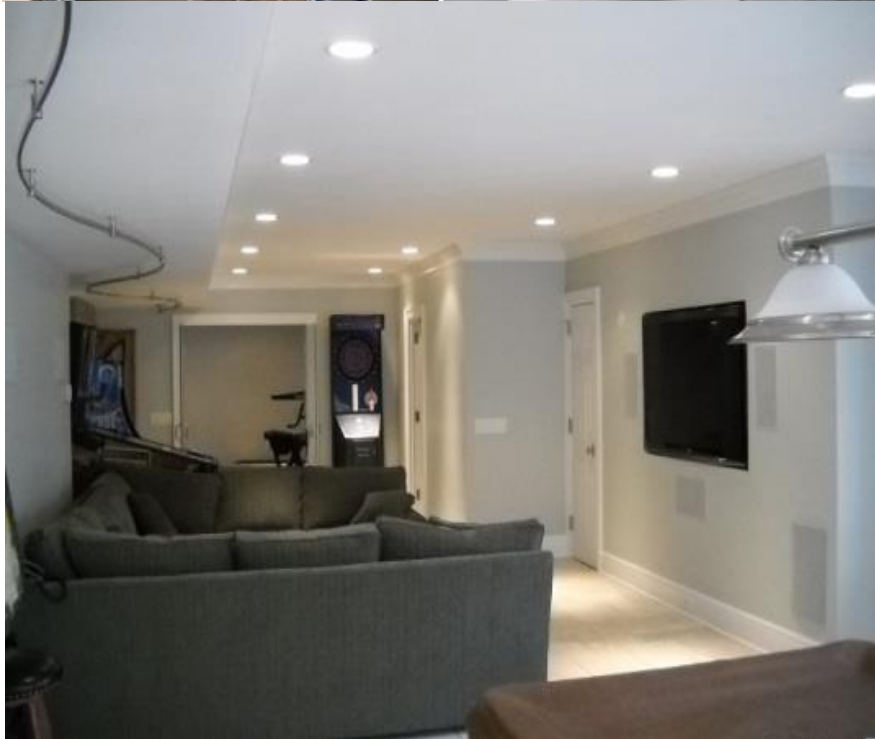
Bottom picture shows the final finished basement.
